# PERFORMANCE REPORT

**ARL Lab Number:**  
**50175**

**Test Method:**  
**Miami-Dade County Protocol TAS 114, Appendix E (1995)**

**Product:**  
**Dryer Vent**

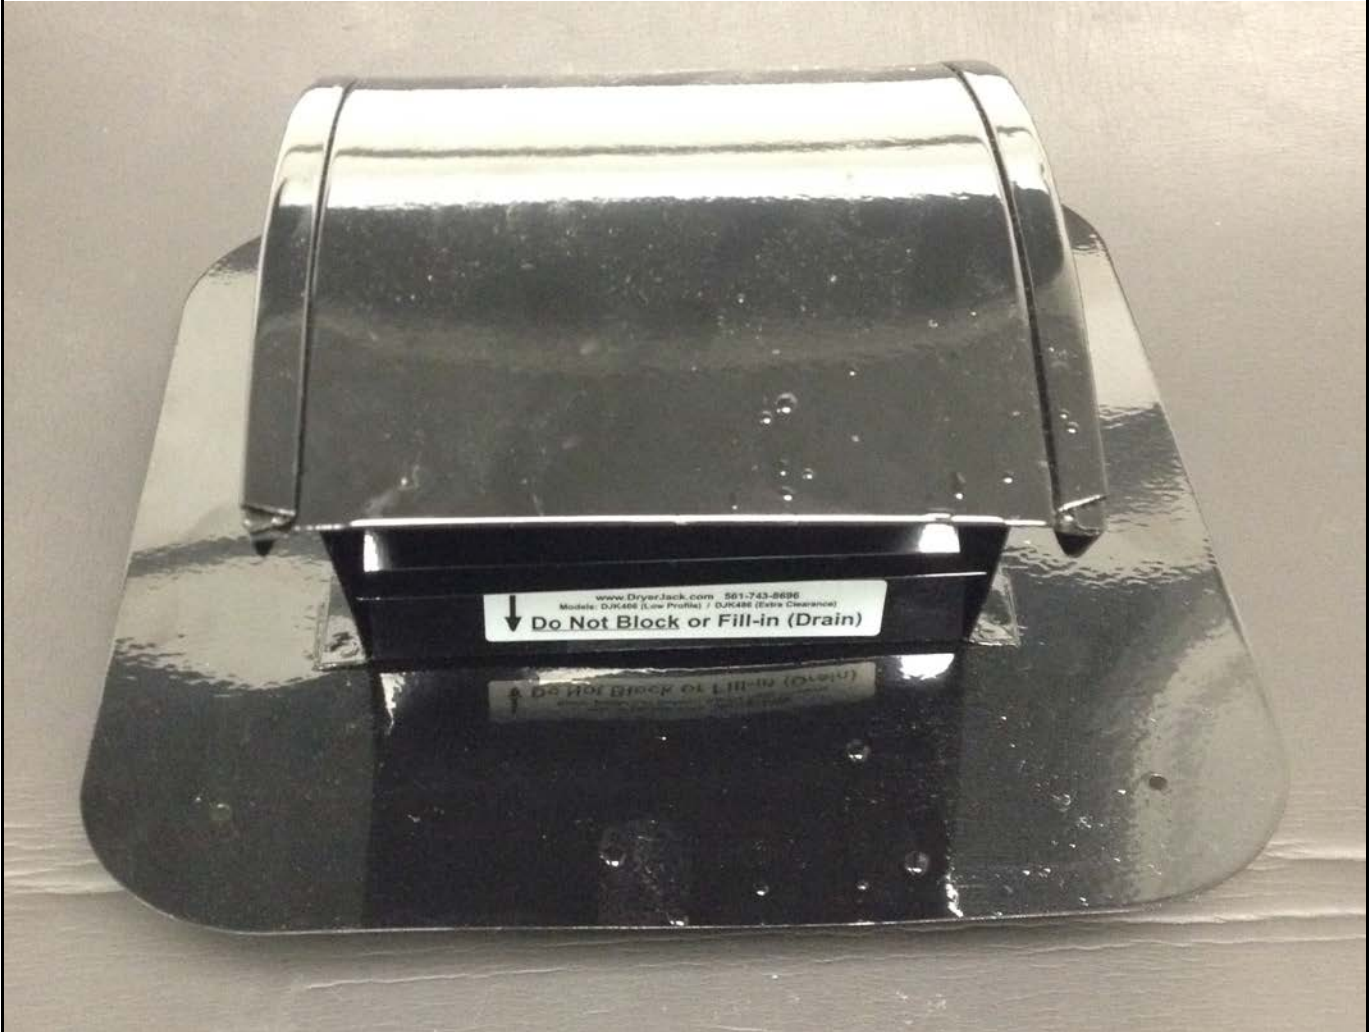
**Photograph 1**  
**Before**

2.4 Photographs of the untested specimen are shown below.

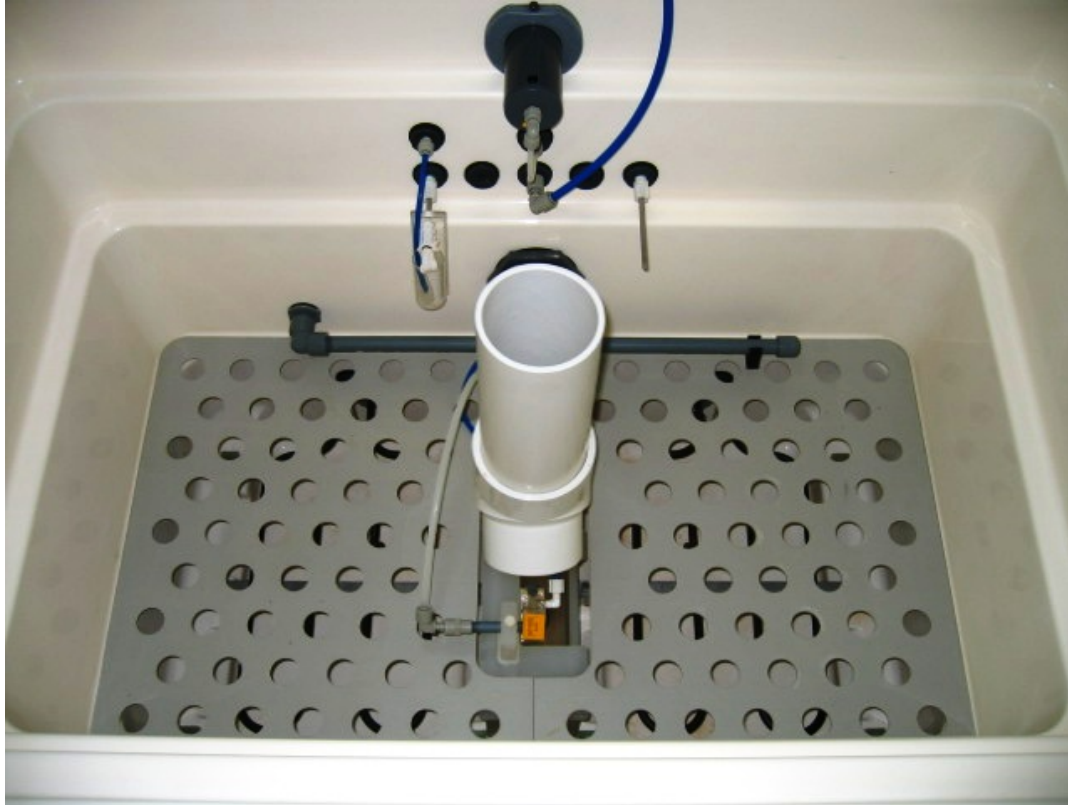
- 3.1 Cyclic Corrosion Test Chamber – The ARL Cyclic Corrosion Test Chamber was utilized to accommodate the parameters of TAS 114, Appendix E, for the purpose of testing the dryer vent. The Chamber, Model CCT10-MB-8AD, was manufactured by Singleton Corporation. The sample space volume is 21 ft<sup>3</sup>. The inside dimensions are 48 x 33 x 24 inches. The Chamber has a temperature range of ambient - 140°F and a humidity range of ambient - 100%.

**Photograph 6**  
**Cyclic Corrosion Test Chamber**
